**Flood Control Project Maintenance
Levee Inspections**

Fall 2018 Levee Maintenance Deficiency Summary Report

San Joaquin River Basin

Reclamation District No. 2101 Blewett

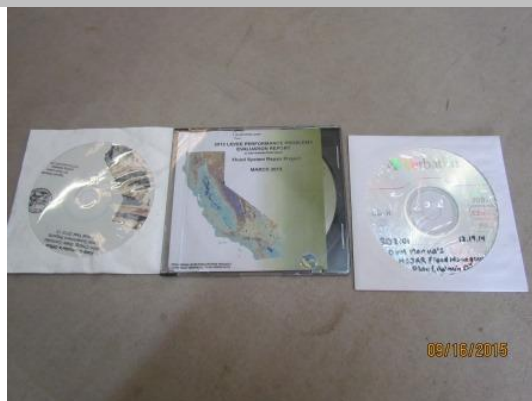
Photo 1 of 1 : FA_2018_RD2101_326_2_20181002_00001.jpg

View of the O&M manual and other documentation.

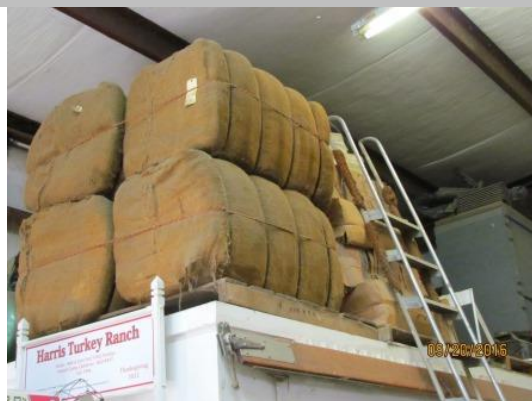
Photo 1 of 2 : FA_2018_RD2101_326_4_20181002_00002.jpg

LM Start		Rating **	A	Issue No.	4		
LM End		Issue Type +	Ma	Location *	N/A		
Category	Earthen Levee			GPS Latitude/Longitude			
				Start		End	
Item	Emergency Supplies & Equipment				o		o
					o		o
DWR ID	DWR_RD2101_01_s_2013_4						
Comment Code							
Inspector Comment							
LMA has emergency supplies on site at the warehouse.

View of the emergency flood fight supplies in the shop.

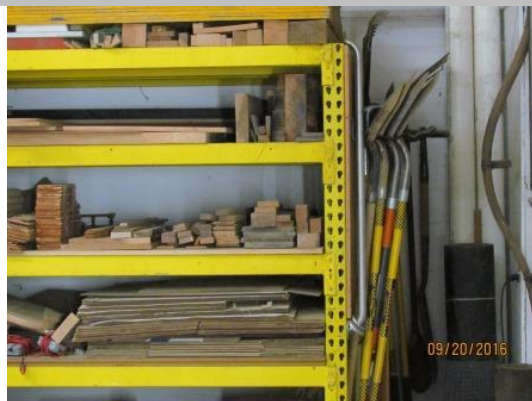
Photo 2 of 2 : FA_2018_RD2101_326_4_20181002_00003.jpg

Another view of the emergency flood fight supplies in the shop.

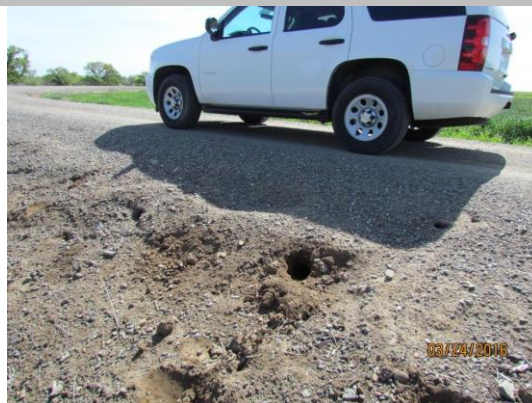
Photo 1 of 1 : FA_2018_RD2101_326_12_20181002_00005.jpg

View of the rodent holes on the waterside levee slope, facing upstream.

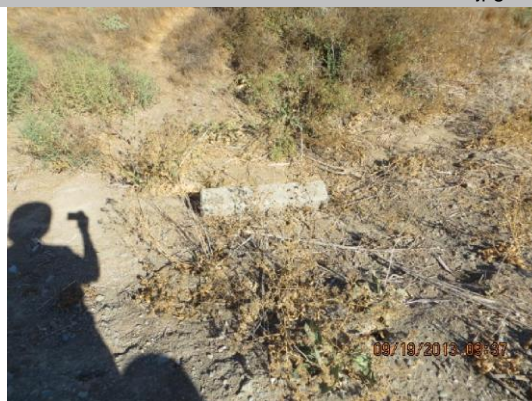
Photo 1 of 3 : UCIP_FA_2018_53384_47962.jpg

Comment Code						
Inspector Comment						
FS_ID:53384 DS_ID:20699 EP_NO: N/A Repair Type: Non-Urgent Crossing Status: Found UCIP Comments: 10/10/2018 The levee does not show any signs of integrity issues and the headwalls are in tact, even though the pipe has heavy sediment buildup. Downgrading to Non-Urgent and recommend cleaning out the pipe to allow drainage to pass through unobstructed (D. Sanoski - DWR UCIP). 11/16/2016 Same as previous inspection slide gate still missing. Also dense vegetation prevents access to crossing. Recommend removing vegetation along pipe alignment and both concrete headwalls to conduct proper inspection of structure. (O. Magana - DWR UCIP)09/17/2013 Slide gate missing from WS toe. Pipe has heavy sediment buildup. (W. Wylie - DWR UCIP) FIELD_STRUCT_DESC: 18-inch corrugated metal drainage pipe through the levee, 3 feet below the crown. Concrete headwalls on both ends. Slide gate at the headwall on the waterside (WS) end. [Additional Reference(s): DWR Levee Log, 1992. USACE San Joaquin O&M Manual 12, December 1968, (HLM 0.05), Drawing No. 07-04-1666, Sheets 1666/18 and 1666/52, (Station 00+70)]. FS Date: 10/10/2018 1:39:00 PM

Headwall on WS toe.

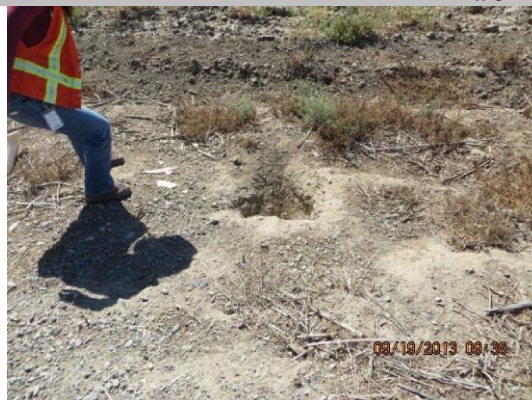
Photo 2 of 3 : UCIP_FA_2018_53384_47961.jpg

Pipe and headwall visible on LS toe.

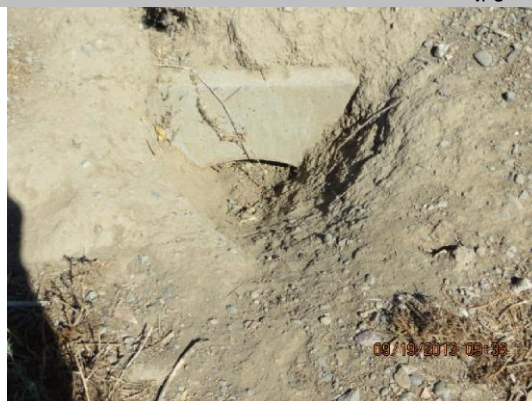
Photo 3 of 3 : UCIP_FA_2018_53384_47960.jpg

Pipe and headwall visible on LS toe.

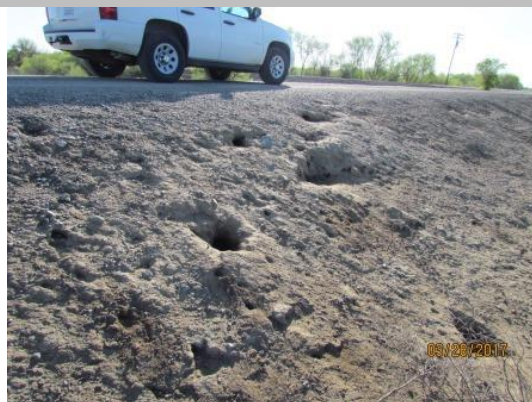
Photo 1 of 3 : FA_2018_RD2101_326_15_20181002_00006.jpg

LM Start	0.10	Rating **	M	Issue No.	15
LM End	0.10	Issue Type +	Ma	Location *	LS
Category	Earthen Levee			GPS Latitude/Longitude	
				Start	End
Item	Animal Control			37.657555 °	37.657555 °
				-121.252902 °	-121.252902 °
DWR ID	DWR_RD2101_01_s_2017_15				
Comment Code					
A1 : Exterminate rodents and backfill and compact or grout burrows.					
Inspector Comment					
Large rodent holes need to be filled. Eradicate Rodents.

View of the rodent burrows on the levee slope.

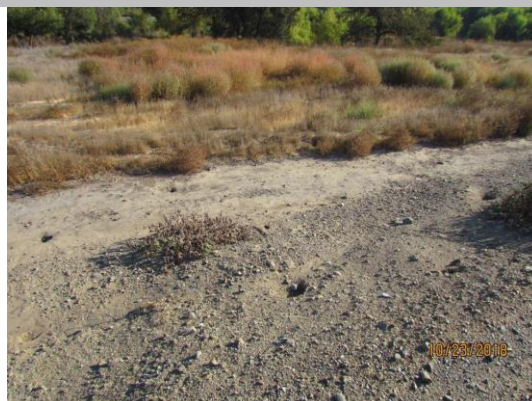
Photo 2 of 3 : FA_2018_RD2101_326_15_20181023_00054.jpg

Burrows on LS slope.

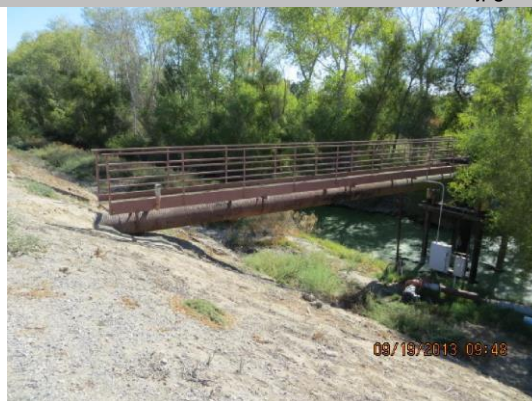
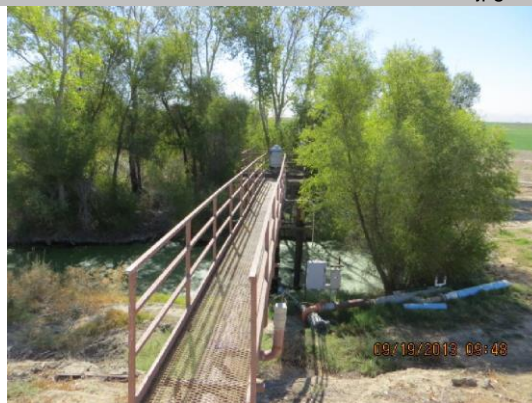
LM Start	0.20	Rating **	A/W	Issue No.	946
LM End	0.20	Issue Type +	Ma	Location *	
Category	Supplemental			GPS Latitude/Longitude	
				Start	End
Item	DWR UCIP LMA Responsibility			37.657130 °	37.657130 °
				-121.251695 °	-121.251695 °
DWR ID	20700				
Comment Code					
Inspector Comment					
FS_ID:20752					
DS_ID:20700					
EP_NO: N/A					
Repair Type: No Action Needed					
Crossing Status: Found					
UCIP Comments:					
FIELD_STRUCT_DESC: 20-inch steel drainage pipe through the levee, 2 feet below the crown. Concrete U-shaped headwall and flap gate on the waterside (WS) end. Pump on pile structure on the landside (LS). [Additional Reference(s): DWR Levee Log, 1992. USACE San Joaquin O&M Manual 12, December 1968, (HLM 0.20), 18-inch pipe listed].					
FS Date: 9/19/2013

Pump on platform at LS.

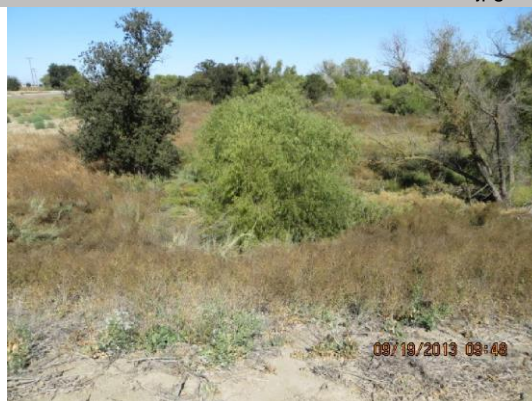
Photo 3 of 3 : UCIP_FA_2018_20752_34978.jpg

Concrete U-shaped headwall on LS toe at willow tree on WS toe.

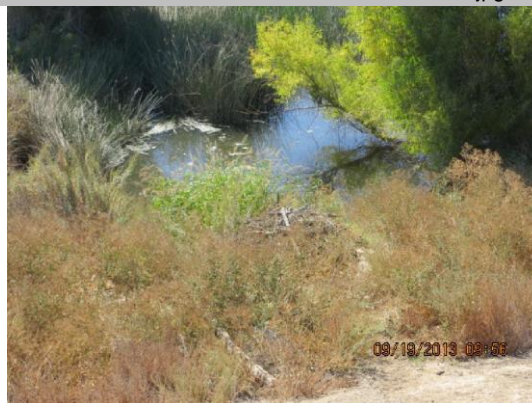
Photo 1 of 3 : UCIP_FA_2018_20785_35046.jpg

LM Start	0.31	Rating **	M	Issue No.	947
LM End	0.31	Issue Type +	Ma	Location *	
Category	Supplemental			GPS Latitude/Longitude	
				Start	End
Item	DWR UCIP LMA Responsibility			37.658142 °	37.658142 °
				-121.250047 °	-121.250047 °
DWR ID	20701				
Comment Code					
Inspector Comment					
FS_ID:20785					
DS_ID:20701					
EP_NO: N/A					
Repair Type: Non-Urgent					
Crossing Status: Found					
UCIP Comments: Inlet blocked by soil from beaver activity. Outlet covered in soil.					
FIELD_STRUCT_DESC: 24-inch corrugated metal drainage pipe through the levee, 21 feet below the crown. Headwall and slide gate on the landside (LS) end. Concrete U-shaped headwall and flap gate on the waterside (WS) end. [Additional Reference(s): DWR Levee Log, 1992. USACE San Joaquin O&M Manual 12, December 1968, (HLM 0.31)].					
FS Date: 9/19/2013

Slide gate at concrete headwall on LS toe.

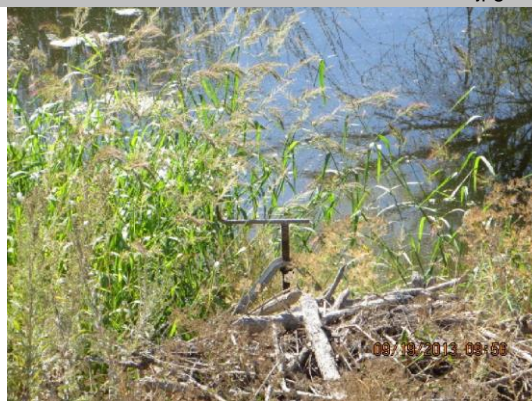
Photo 2 of 3 : UCIP_FA_2018_20785_35045.jpg

Slide gate at concrete headwall on LS toe.

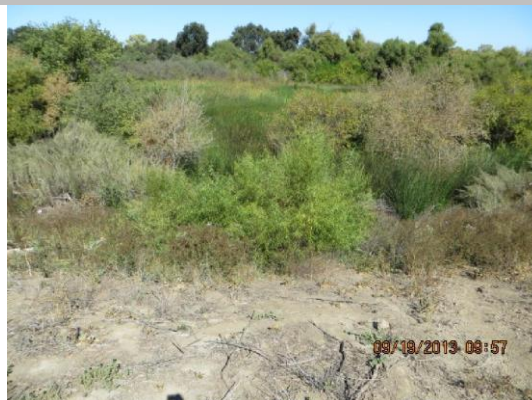
Photo 3 of 3 : UCIP_FA_2018_20785_35044.jpg

Outlet covered in soil but likely at willow tree on WS slope.

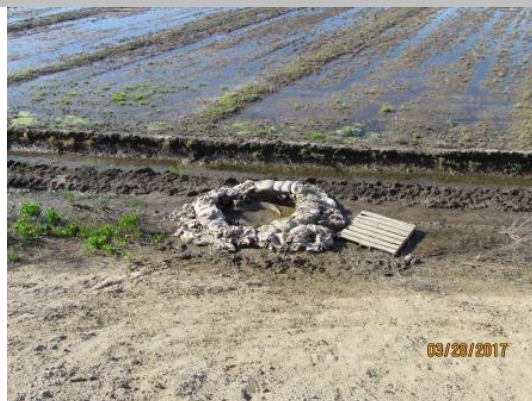
Photo 1 of 1 : FA_2018_RD2101_326_16_20181002_00007.jpg

View of the boil and seepage area at the levee toe. Spring 2017.

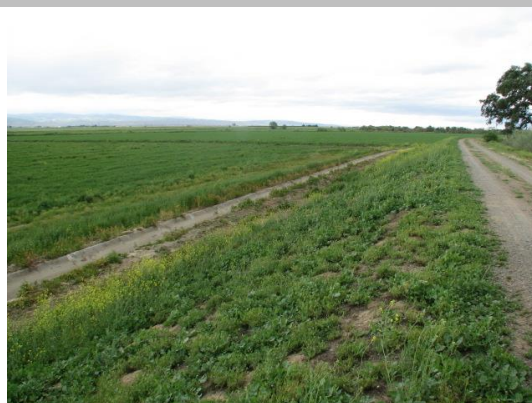
Photo 1 of 1 : FA_2018_RD2101_326_944_20181002_00023.jpg

LM Start	0.73	Rating **	M	Issue No.	944
LM End	1.76	Issue Type +	En	Location *	LS
Category	Earthen Levee			GPS Latitude/Longitude	
				Start	End
Item	Encroachments			37.659827 °	37.651049 °
				-121.243675 °	-121.231475 °
DWR ID	DWR_RD2101_01_s_2012_944				
Comment Code					
DT : Ditch					
Inspector Comment

Concrete ditch near landside toe.

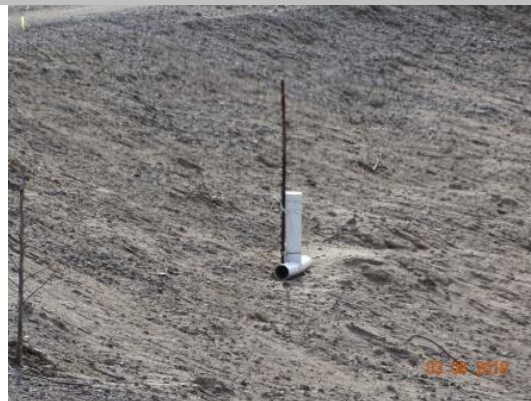
Photo 1 of 1 : FA_2018_RD2101_326_19_20181002_00008.jpg

View of the bait station on the levee slope.

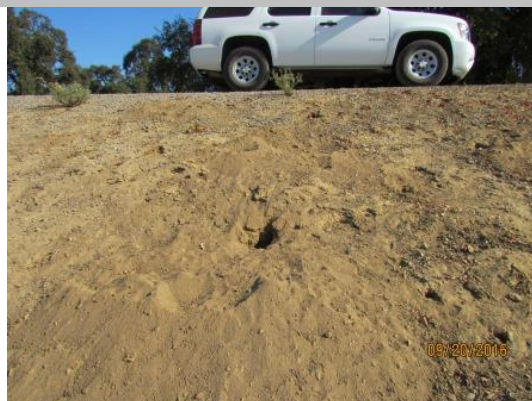
Photo 1 of 1 : FA_2018_RD2101_326_21_20181002_00009.jpg

View of the rodent hole on the landside slope.

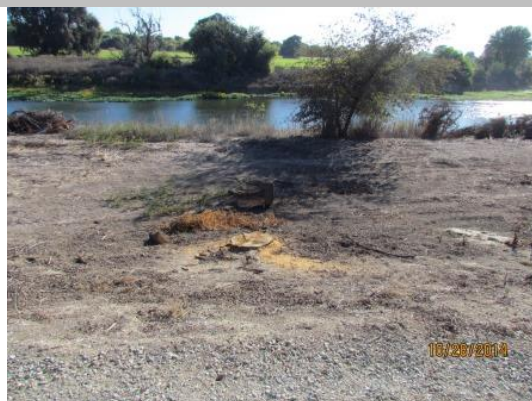
Photo 1 of 1 : FA_2018_RD2101_326_33_20181002_00017.jpg

View of the tree stump at the waterside levee toe.

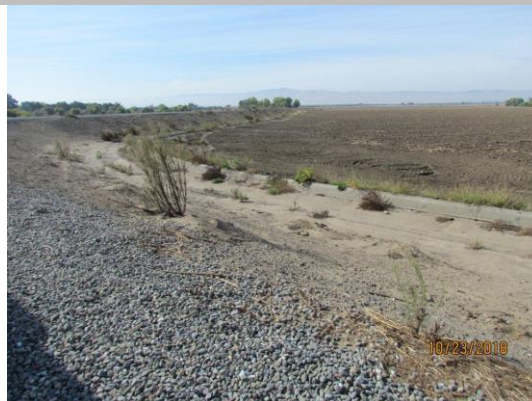
Photo 1 of 2 : FA_2018_RD2101_326_24_20181023_00056.jpg

LM Start	2.23	Rating **	U	Issue No.	24
LM End	2.23	Issue Type +	Ma	Location *	LS
Category	Earthen Levee			GPS Latitude/Longitude	
				Start	End
Item	Animal Control			37.647088 °	37.647088 °
				-121.225077 °	-121.225077 °
DWR ID	DWR_RD2101_01_s_2017_24				
Comment Code					
A2 : Repair the levee slope damaged by livestock and prevent large animal access.					
Inspector Comment					
Rodents have been eradicated need to backfill holes.

View of large burrows on LS slope.

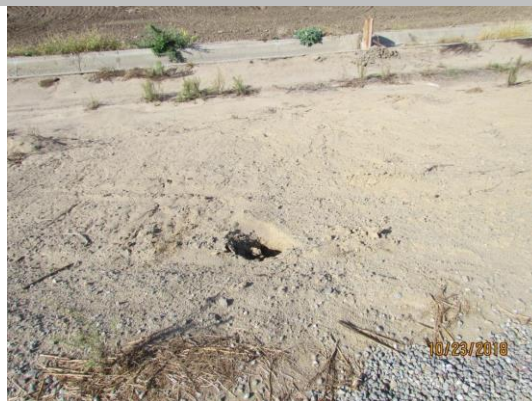
Photo 2 of 2 : FA_2018_RD2101_326_24_20181023_00057.jpg

View of collapsed burrow on LS shoulder.

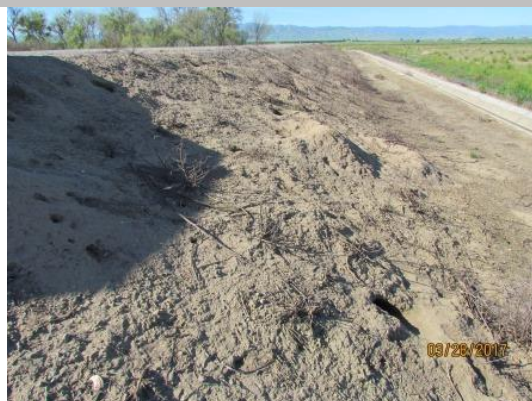
Photo 1 of 1 : FA_2018_RD2101_326_37_20181002_00019.jpg

View of the multiple rodent burrows on the levee slope.

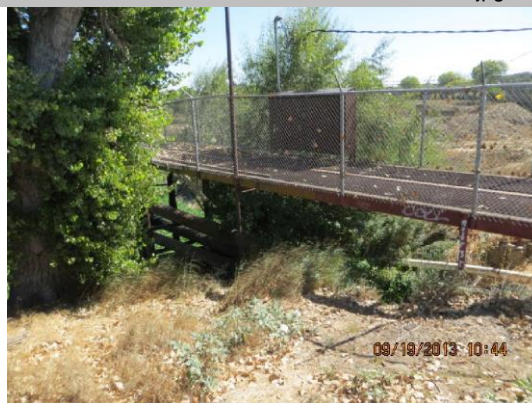
Photo 1 of 3 : UCIP_FA_2018_20865_35110.jpg

Comment Code						
Inspector Comment						
FS_ID:20865						
DS_ID:20711						
EP_NO: N/A						
Repair Type: Non-Urgent						
Crossing Status: Found						
UCIP Comments: Pipe leaking at pipe/concrete connection on WS slope.						
FIELD_STRUCT_DESC: 2 of 3: 20-inch concrete encased steel irrigation pipe through the levee, 10 feet below the crown. Pump on steel pier on the waterside (WS). Gate valve in a 16-foot by 7-foot concrete vault on the WS shoulder. Pipes discharge into a concrete canal on the landside (LS) toe. [Additional Reference(s): DWR Levee Log, 1992. USACE San Joaquin O&M Manual 12, December 1968, (HLM 2.73)].						
FS Date: 9/19/2013

Pump on metal pier on WS.

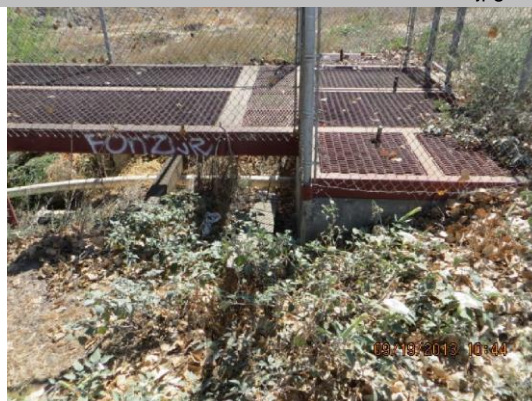
Photo 2 of 3 : UCIP_FA_2018_20865_35109.jpg

Gate valve in concrete vault on WS shoulder.

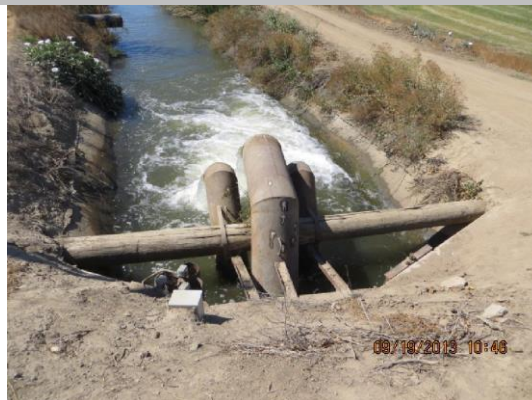
Photo 3 of 3 : UCIP_FA_2018_20865_35108.jpg

20-inch steel pipe discharges into concrete channel on LS.

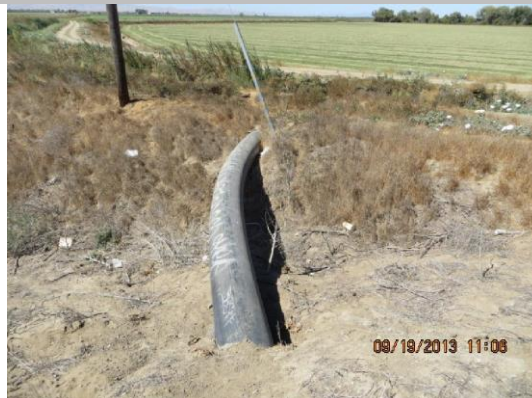
Photo 1 of 2 : UCIP_FA_2018_22915_39043.jpg

LM Start	2.72	Rating **	M	Issue No.	949
LM End	2.72	Issue Type +	En	Location *	
Category	Supplemental			GPS Latitude/Longitude	
				Start	End
Item	DWR UCIP Field Study			37.641798 °	37.641798 °
				-121.229714 °	-121.229714 °
DWR ID	24679				
Comment Code					
Inspector Comment					
FS_ID:22915 DS_ID:24679 EP_NO: N/A Repair Type: Non-Urgent Crossing Status: Found UCIP Comments: 09/26/2016 - (T. Hatch/UCIP) Inspector indicated that pipe had been removed for several years. Need additional information to determine if the pipe was removed properly and the levee recompacted to specifications. 09/19/2013 - (W. Wylie/UCIP) No permit identified for this crossing. FIELD_STRUCT_DESC: *REMOVED* 18-inch polyvinyl chloride (PVC) irrigation pipe through the levee, 3.5 feet below the crown. No pump or other appurtenances visible. FS Date: 9/19/2013

18-inch PVC pipe visible at LS slope.

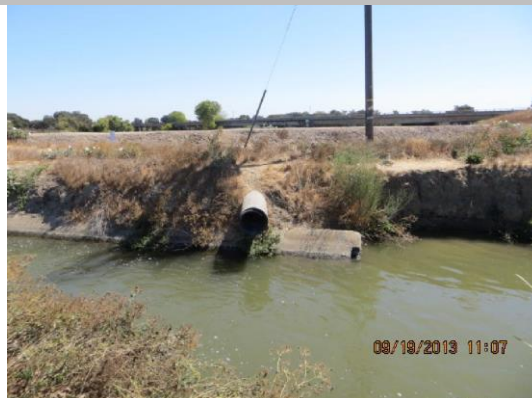
Photo 2 of 2 : UCIP_FA_2018_22915_39042.jpg

18-inch PVC pipe visible at outlet to irrigation canal on LS slope.

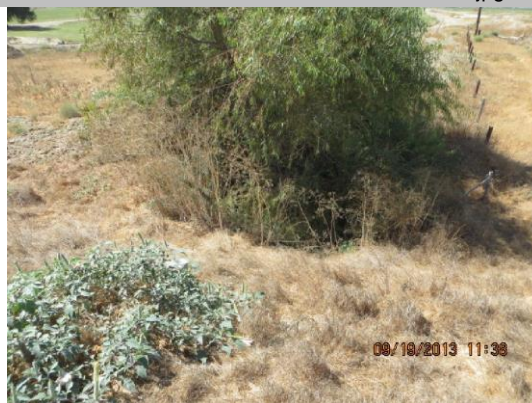
Photo 1 of 3 : UCIP_FA_2018_53201_35142.jpg

Comment Code						
Inspector Comment						
FS_ID:53201 DS_ID:20705 EP_NO: N/A Repair Type: Non-Urgent Crossing Status: Found UCIP Comments: 10/10/2018 Although there was heavy vegetation, there were no visible levee or pipe threats; downgrading to Non-Urgent (D. Sanoski - DWR UCIP).11/16/2016 No access available. Need to coordinate with LMA to obtain access for proper inspection at a later date. (O. Magana - DWR UCIP)09/19/2013 Flap gate missing from WS headwall. (W. Wylie - DWR UCIP) FIELD_STRUCT_DESC: 24-inch corrugated metal drainage pipe through the levee, 11 feet below the crown. Concrete U-shaped headwalls on both ends. Flap gate on the waterside (WS) end. [Additional Reference(s): DWR Levee Log, 1992. USACE San Joaquin O&M Manual 12, December 1968, (HLM 2.85), Drawing No. 07-04-1666, Sheets 1666/13 and 1666/51, (Station 421+30)]. FS Date: 10/10/2018 2:24:25 PM

Concrete headwall visible at LS toe in ditch.

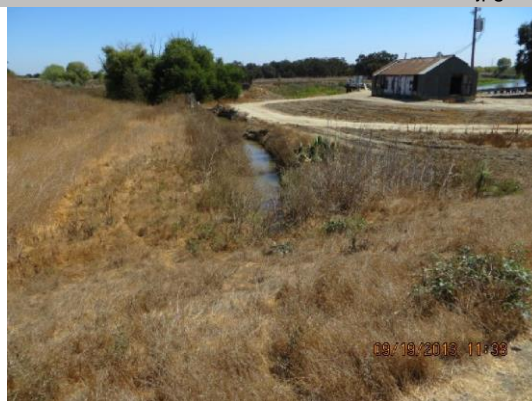
Photo 2 of 3 : UCIP_FA_2018_53201_35141.jpg

Concrete headwall visible on WS toe at canal.

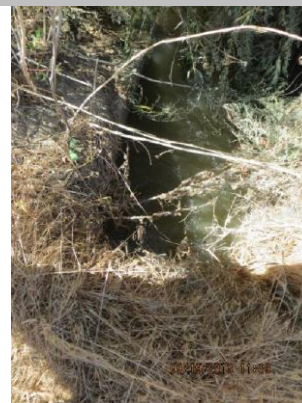
Photo 3 of 3 : UCIP_FA_2018_53201_35140.jpg

Concrete headwall at LS toe.

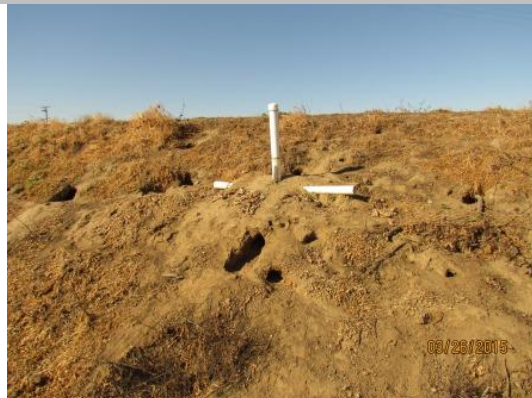
Photo 1 of 1 : FA_2018_RD2101_326_27_20181002_00012.jpg

LM Start	2.83	Rating **	U	Issue No.	27
LM End	2.83	Issue Type +	Ma	Location *	WS
Category	Earthen Levee			GPS Latitude/Longitude	
				Start	End
Item	Animal Control			37.640425 °	37.640425 °
				-121.230139 °	-121.230139 °
DWR ID	DWR_RD2101_01_s_2012_27				
Comment Code					
A3 : No rodents visible, but rodent burrows visible; need to backfill and compact or grout burrows.					
Inspector Comment					
Burrows on both sides of levee. Backfill the burrows to restore the levee to original condition.

View of multiple rodent holes on the levee slope.

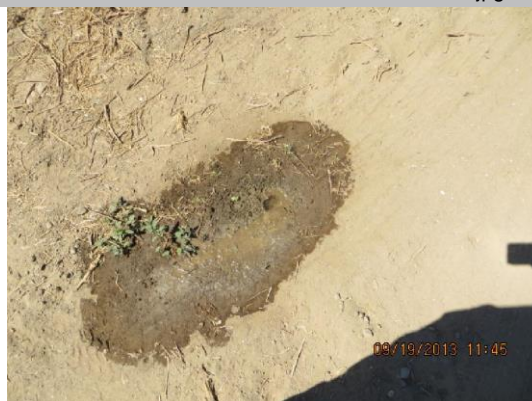
Photo 1 of 3 : UCIP_FA_2018_20873_35146.jpg

Comment Code					
Inspector Comment					
FS_ID:20873 DS_ID:20706 EP_NO: N/A Repair Type: Non-Urgent Crossing Status: Found UCIP Comments: Leaks off LS toe may indicate internal failure. Good candidate for video inspection. FIELD_STRUCT_DESC: 1 of 2: 24-inch reinforced concrete irrigation pipe through the levee, 11 feet below the crown. Pump on metal pier at the berm. Screw gates in a 6-foot by 10.5-foot concrete box on the waterside (WS). 12-inch steel riser next to concrete box with slide gates. Abandoned pump house on the WS. [Additional Reference(s): DWR Levee Log, 1992. USACE San Joaquin O&M Manual 12, December 1968, (HLM 2.87)]. FS Date: 9/19/2013

Leak in pipe off LS toe.

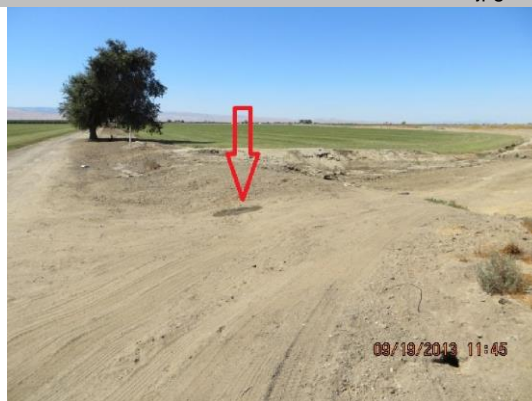
Photo 2 of 3 : UCIP_FA_2018_20873_35145.jpg

Leak in pipe off LS toe.

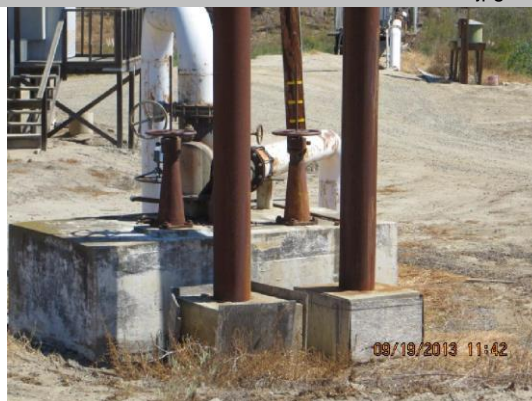
Photo 1 of 3 : UCIP_FA_2018_20874_35151.jpg

LM Start	2.85	Rating **	M	Issue No.	952	
LM End	2.85	Issue Type +	En	Location *		
Category	Supplemental			GPS Latitude/Longitude		
				Start	End	
Item	DWR UCIP Field Study			37.640185 °	37.640185 °	
				-121.230067 °	-121.230067 °	
DWR ID	20712					
Comment Code						
Inspector Comment						
FS_ID:20874 DS_ID:20712 EP_NO: N/A Repair Type: Non-Urgent Crossing Status: Found UCIP Comments: Leak off LS toe may indicate internal failure. Good candidate for video inspection. FIELD_STRUCT_DESC: 2 of 2: 30-inch reinforced concrete irrigation pipe through the levee, 11 feet below the crown. Pump on metal pier on the berm. 12-inch steel riser next to a 6-foot by 10.5-foot concrete box with a screw gate inside on the waterside (WS). Abandoned pump house on the WS. [Additional Reference(s): DWR Levee Log, 1992. USACE San Joaquin O&M Manual 12, December 1968, (HLM 2.87)]. FS Date: 9/19/2013

Gatevalve in concrete vault with standpipe off WS toe.

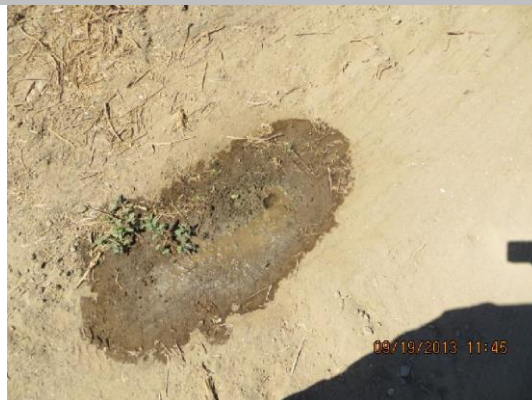
Photo 2 of 3 : UCIP_FA_2018_20874_35150.jpg

Leak in pipe off LS toe.

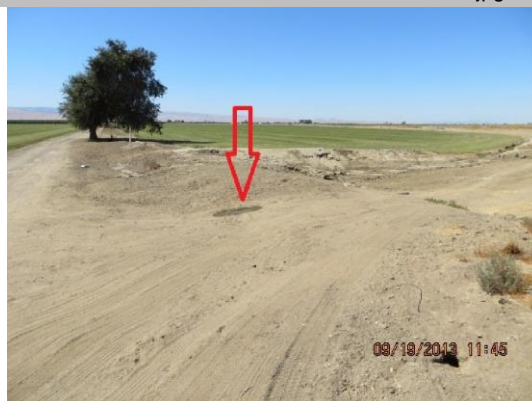
Photo 3 of 3 : UCIP_FA_2018_20874_35149.jpg

Comment Code						
Inspector Comment						
FS_ID:20874 DS_ID:20712 EP_NO: N/A Repair Type: Non-Urgent Crossing Status: Found UCIP Comments: Leak off LS toe may indicate internal failure. Good candidate for video inspection. FIELD_STRUCT_DESC: 2 of 2: 30-inch reinforced concrete irrigation pipe through the levee, 11 feet below the crown. Pump on metal pier on the berm. 12-inch steel riser next to a 6-foot by 10.5-foot concrete box with a screw gate inside on the waterside (WS). Abandoned pump house on the WS. [Additional Reference(s): DWR Levee Log, 1992. USACE San Joaquin O&M Manual 12, December 1968, (HLM 2.87)]. FS Date: 9/19/2013

Leak in pipe off LS toe.

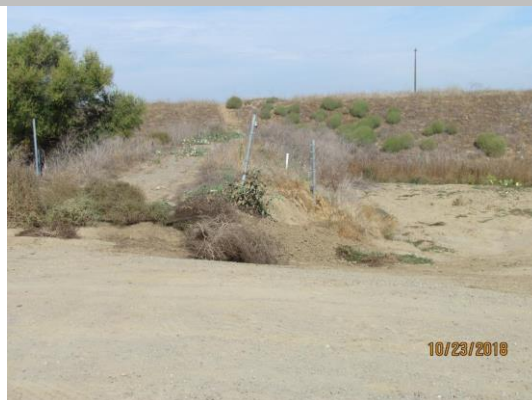
Photo 1 of 2 : FA_2018_RD2101_326_44_20181023_00058.jpg

Damage on WS slope and crown.

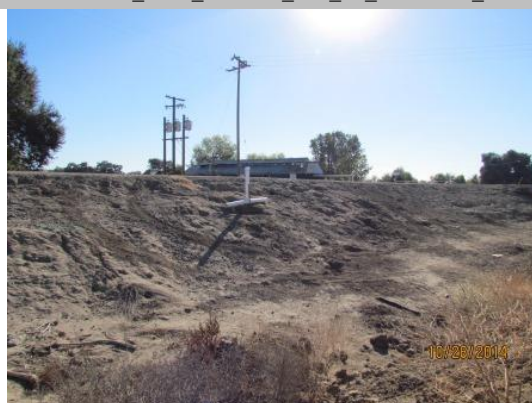
Photo 1 of 1 : FA_2018_RD2101_326_28_20181002_00013.jpg

LM Start	2.85	Rating **	M	Issue No.	28
LM End	2.85	Issue Type +	Ma	Location *	LS
Category	Earthen Levee			GPS Latitude/Longitude	
				Start	End
Item	Animal Control			37.640134°	37.640134°
				-121.230019°	-121.230019°
DWR ID	DWR_RD2101_01_s_2012_28				
Comment Code					
A3 : No rodents visible, but rodent burrows visible; need to backfill and compact or grout burrows.					
Inspector Comment					
Rodent holes were backfilled but some are still active. Continue to monitor the area and exterminate the rodents.

View of numerous rodent holes with bait stations present.

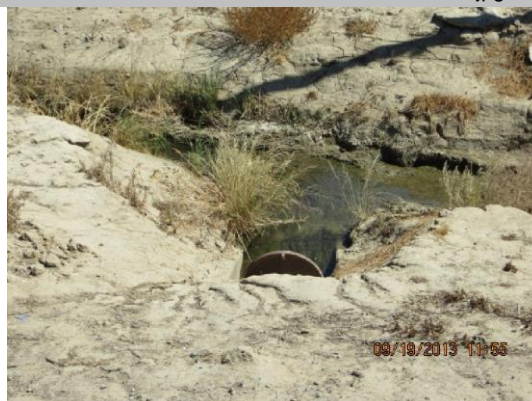
Photo 1 of 3 : UCIP_FA_2018_20875_35156.jpg

Flapgate on WS toe at concrete headwall.

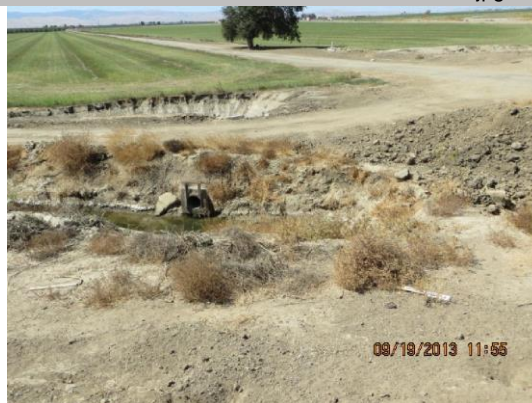
Photo 2 of 3 : UCIP_FA_2018_20875_35155.jpg

Inlet on LS toe with concrete headwall.

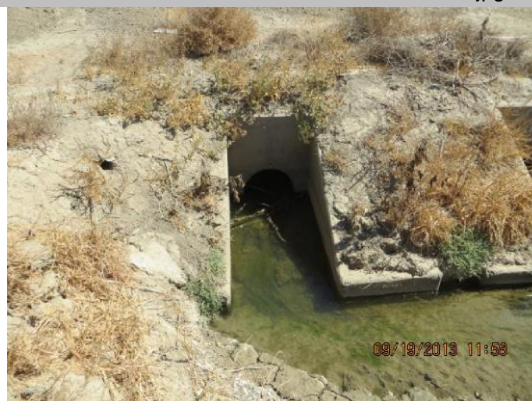
Photo 3 of 3 : UCIP_FA_2018_20875_35154.jpg

Inlet on LS toe with concrete headwall.

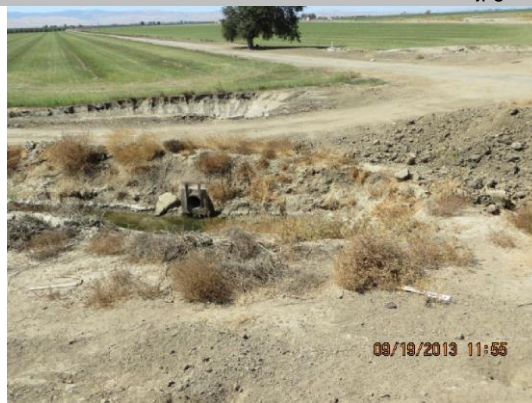
Photo 1 of 3 : UCIP_FA_2018_20876_35159.jpg

Concrete inlet on LS toe at canal.

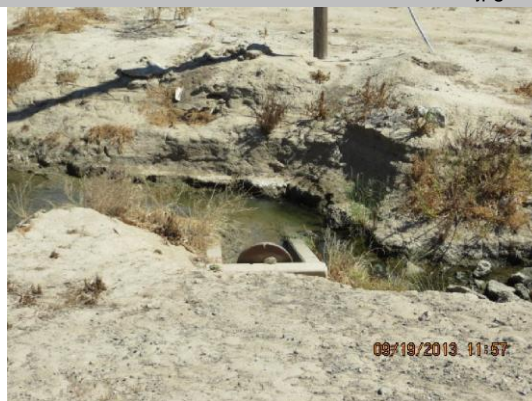
Photo 2 of 3 : UCIP_FA_2018_20876_35158.jpg

Concrete U-shaped headwall on WS toe with flapgate.

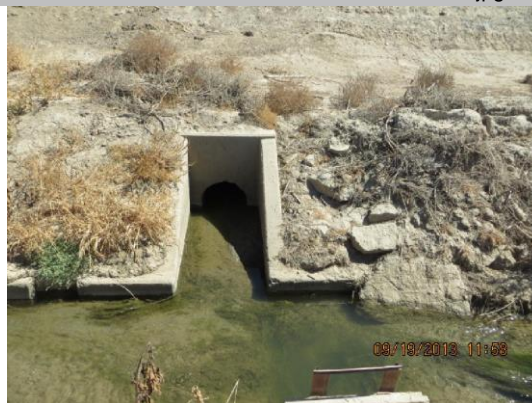
Photo 3 of 3 : UCIP_FA_2018_20876_35157.jpg

Concrete inlet on LS toe at canal.

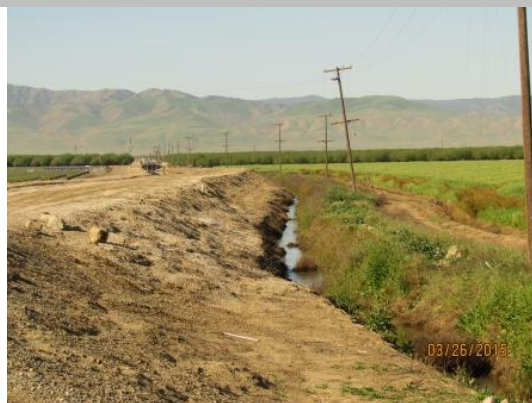
Photo 1 of 1 : FA_2018_RD2101_326_8_20181002_00004.jpg

View of the ditch at the landside levee toe.

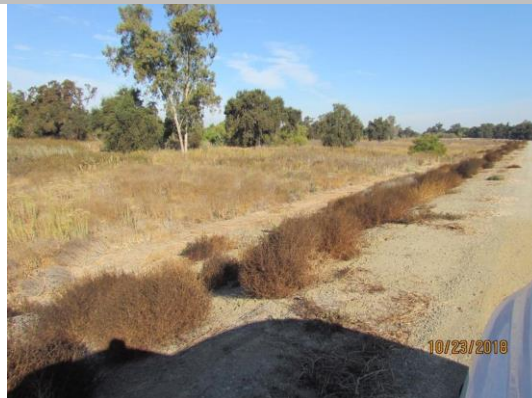
Photo 1 of 1 : FA_2018_RD2101_327_1_20181023_00001.jpg

Vegetation typical of levee slope in this area.
